F/O ID	RN110797057		
F/O Name	BULLDOG ENVIRONMENTAL ANTON UNA SITE		
F/O Physical Address	213 N MAIN ST		
Location City	ANTON	Location Zip	79313
Location County	HOCKLEY	Operational Status	Active
Primary Business Activity	Environmental Clean-ups	Type of Small Entity	Small Business
SNC or HPV?	SNC	SIC Code	
Potentially Affected Area	HUMAN HEALTH AND THE ENVIRONMENT	Complaints Closed	1
List any NOV's? Orders for same or similar violations at this F/O in the past 5 years.			
Additional IDs	455020064

COMP CG_HOCKLEY_CP_20190525_INVESTIGATION
Texas Commission on Environmental Quality
Investigation Report

Activity Type(s): IHWCMPL - Complaint investigation
MSWUNA - Investigation at a site that
is in violation of 330.7, including
illegal disposal of tires

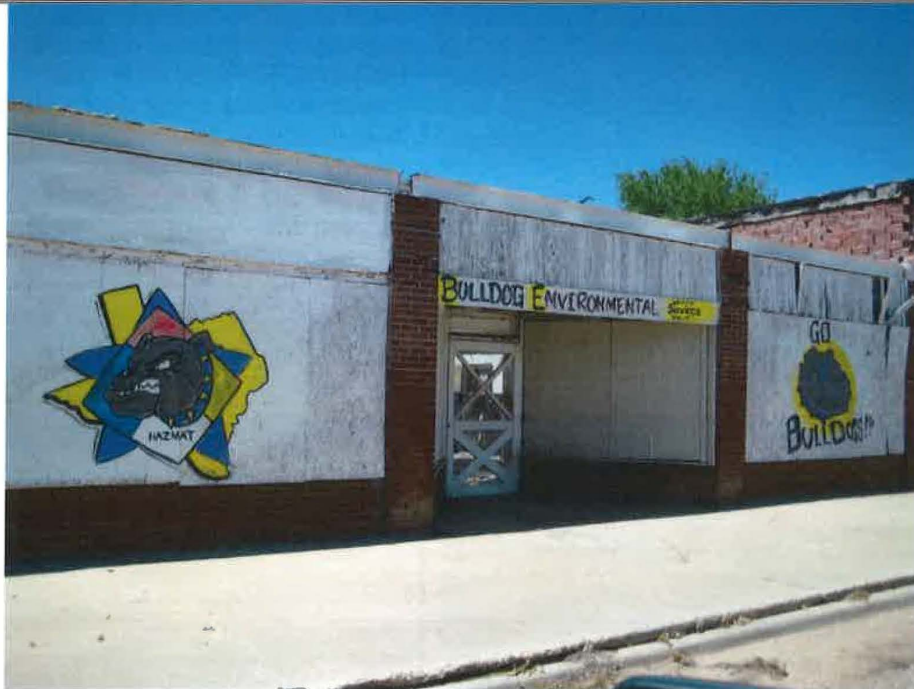
1) UNA Site

Bulldog Environmental Services, the Regulated Entity (RE), building front located 213 Main St., Anton, TX. Note screen door with no locks to secure building.

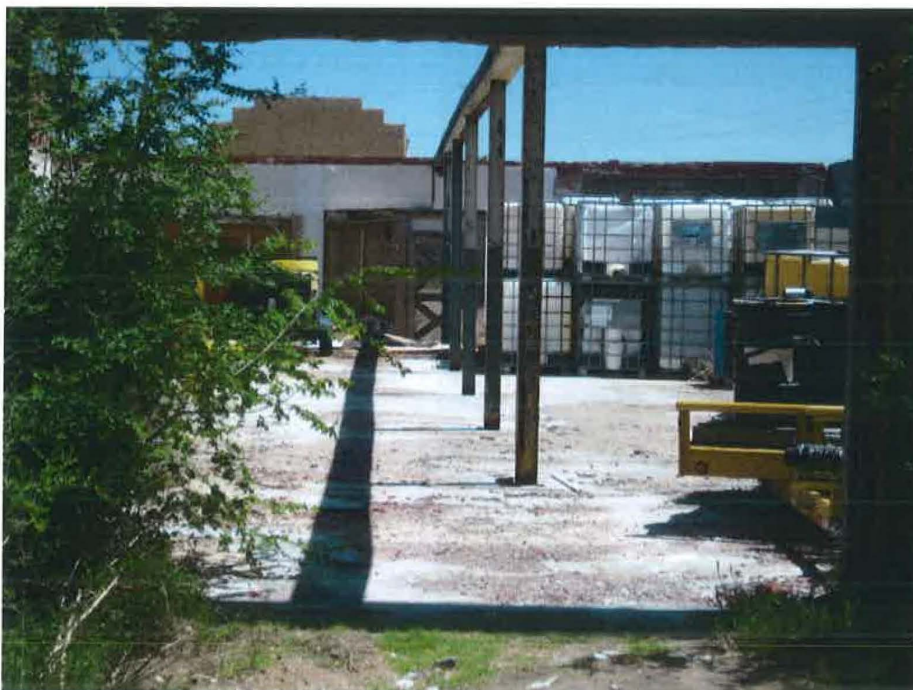
2) UNA Site

Rear of the RE. No back door and open to the public. Totes, drums, and overpacks can be seen through the back of the building.

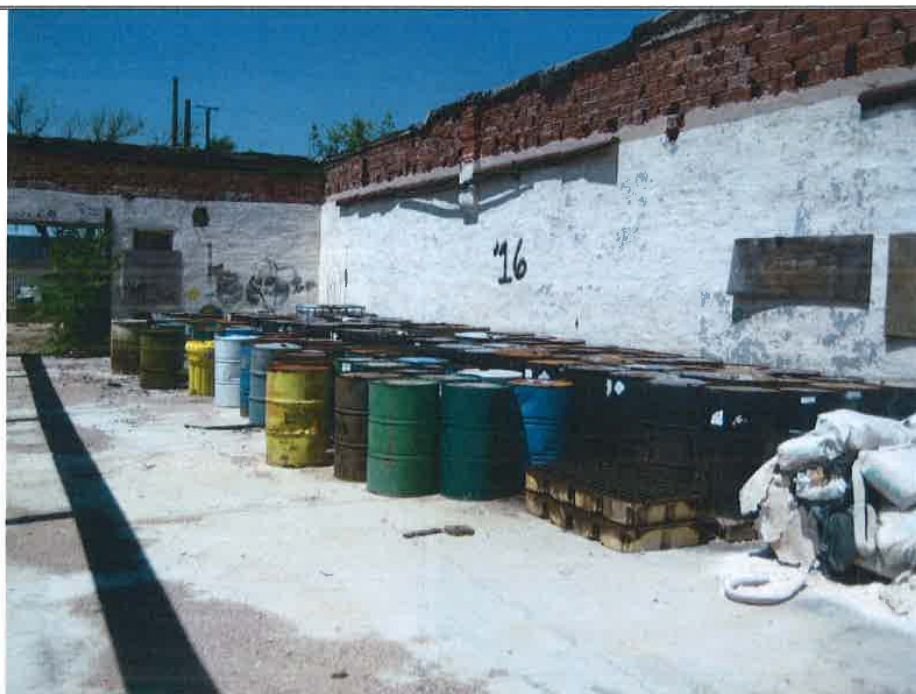
3) UNA Site

Looking west at multiple 55 gallon and 30 gallon drums with unknown waste contents. One overpack. Many of the drums are bulging on-top. Drums are not labeled as to their contents. Many drums damaged. Some are missing lids.

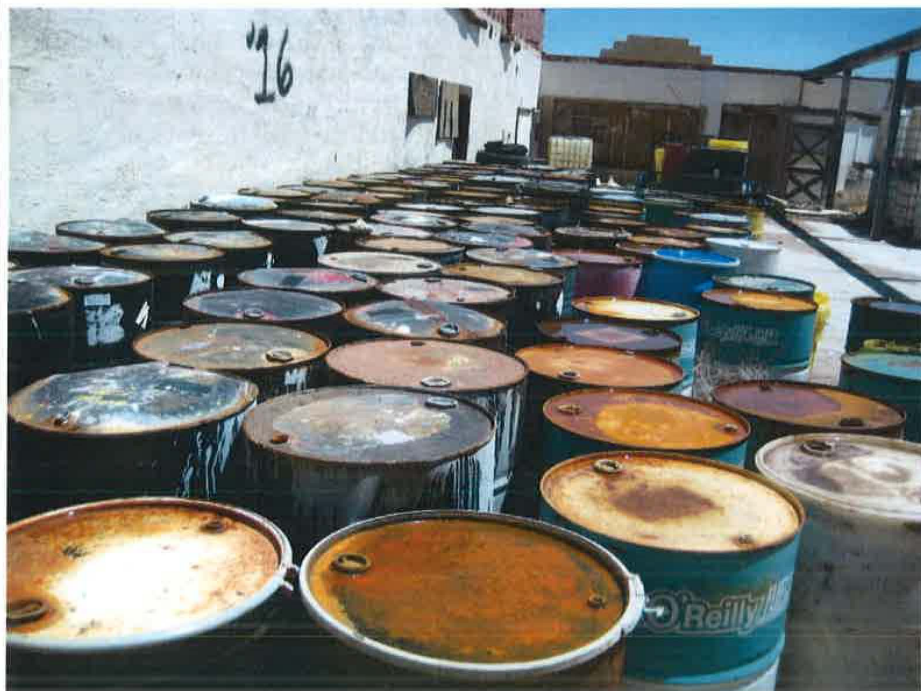
4) UNA Site

Looking east at multiple 55 gallon and 30 gallon drums with unknown waste contents. One overpack. Many of the drums are bulging on-top. Drums are not labeled as to their contents. Many drums damaged. Some are missing lids.

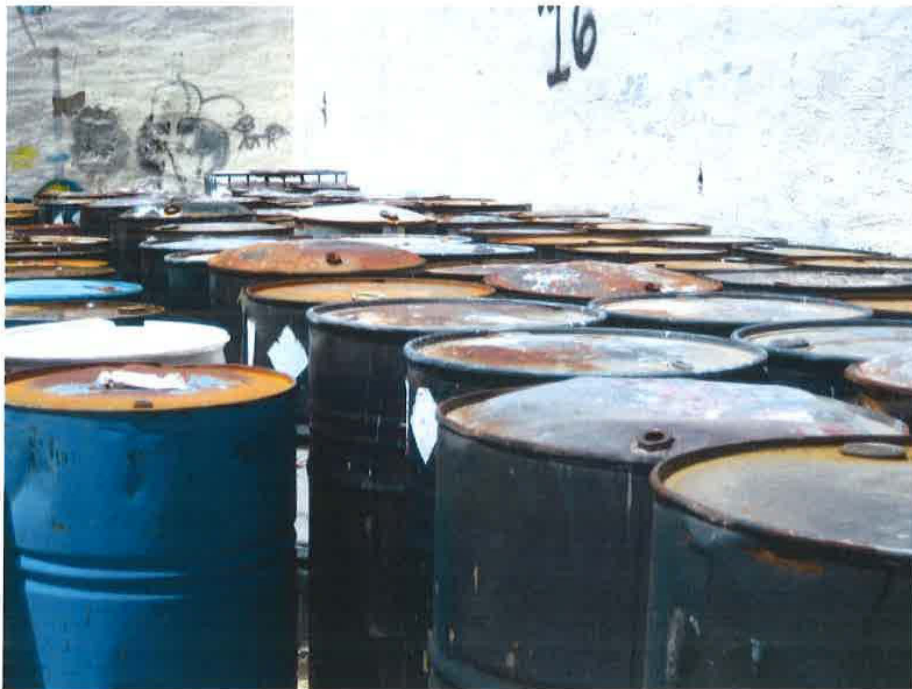
5) UNA Site

Looking west at multiple 55 gallon and 30 gallon drums with unknown waste contents. One overpack. Many of the drums are bulging on-top. Drums are not labeled as to their contents. Many drums damaged.

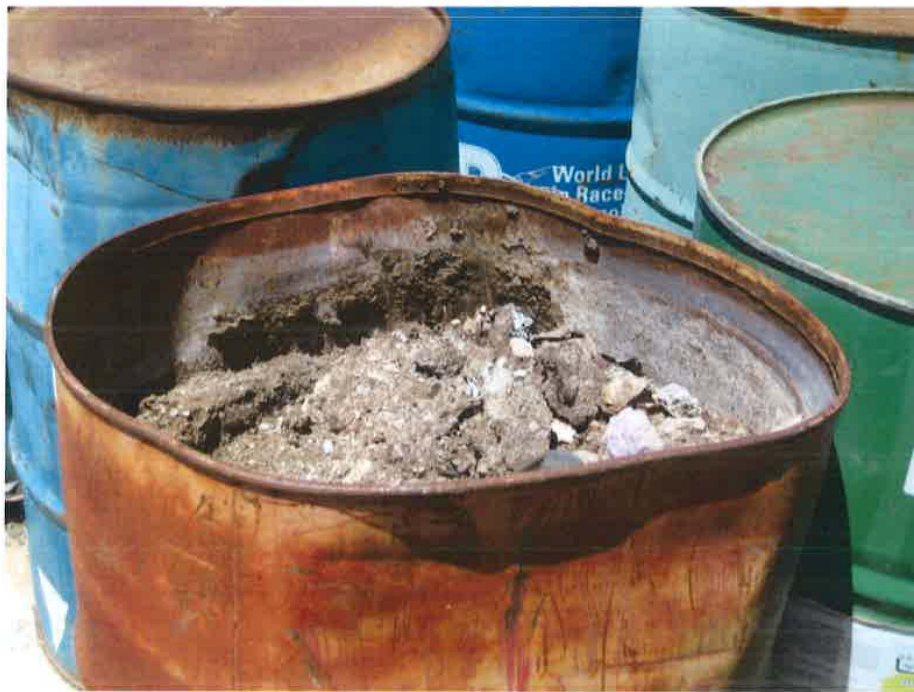
6) UNA Site

One of the drums with an unknown solid waste missing the lid and no labeling.

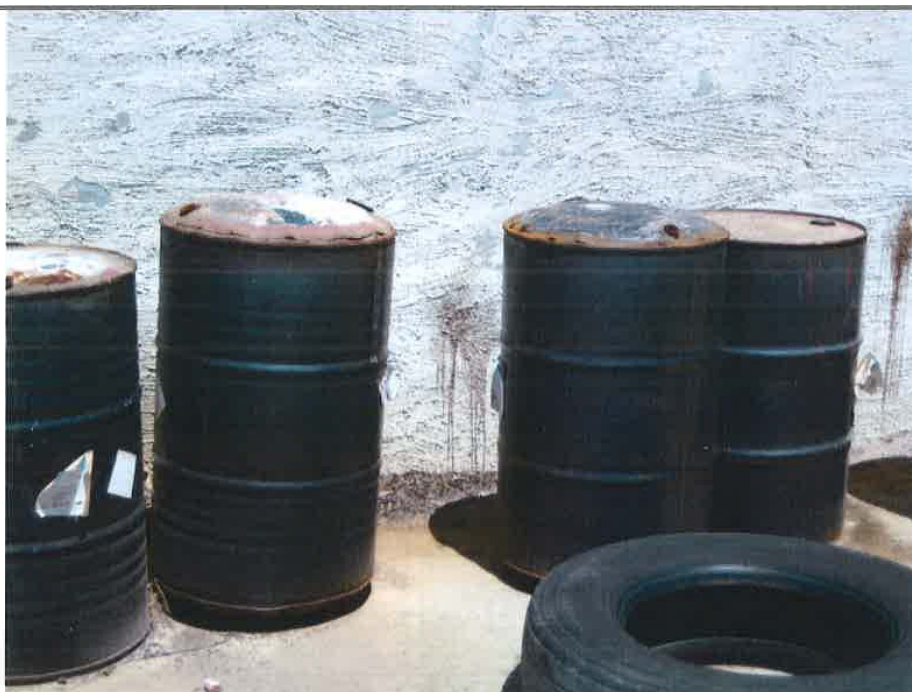
7) UNA Site

Two of the drums have bulged on both ends. No labeling as to contents. Dried paint was observed around the top of both drums.

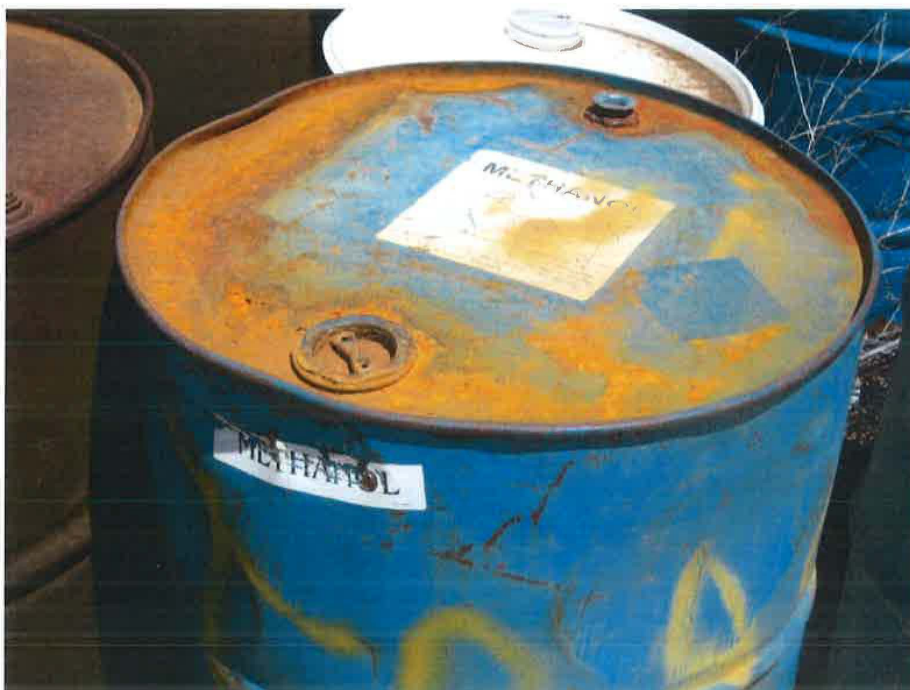
8) UNA Site

One drum labeled Methanol. The drum is not empty. Small bung is not completely closed.

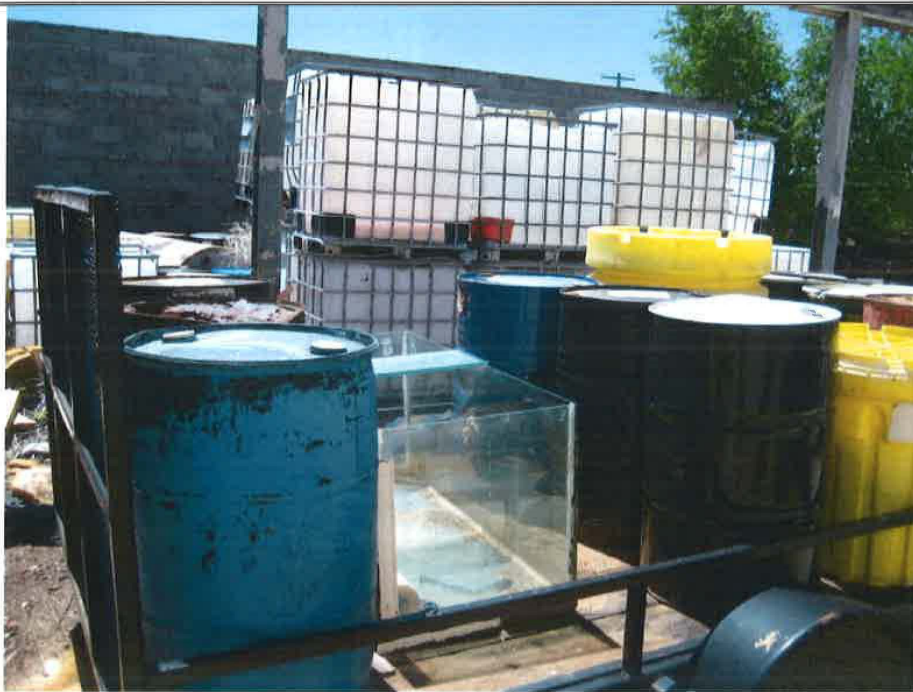
9) UNA Site

Looking south at a trailer inside the building with multiple unlabeled drums and overpacks. Drums and overpacks appear to contain an unknown waste substance. One drum is bulging on-top and one the top has rusted out. In the background there are chemical totes some have unknown waste stored inside.

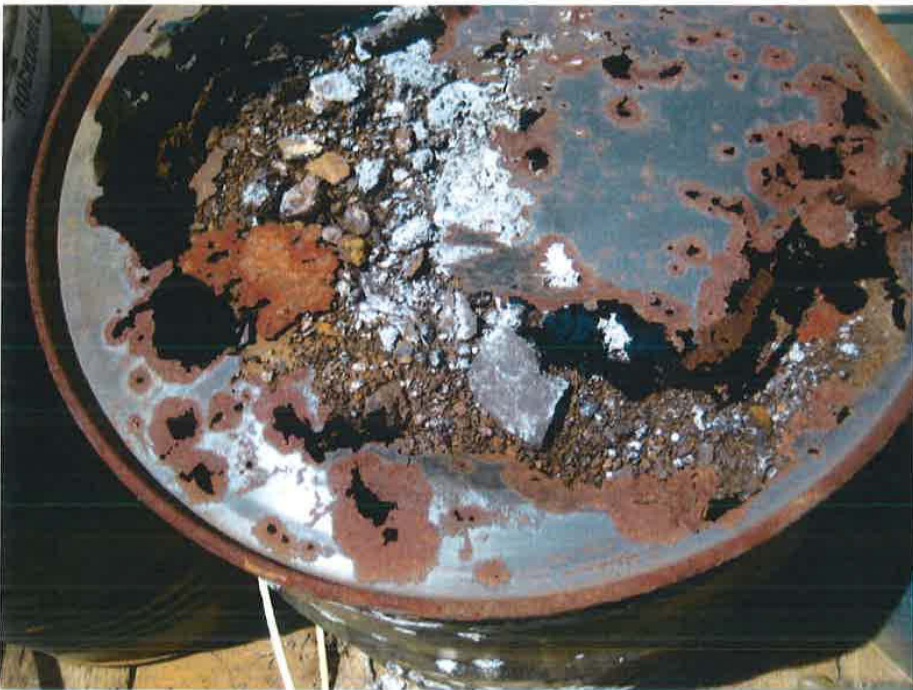
10) UNA Site

One drum on the small trailer in photo #9 with the top corroded away exposing the inside unknown solid waste. It does not appear that the waste in the container is compatible with the waste.

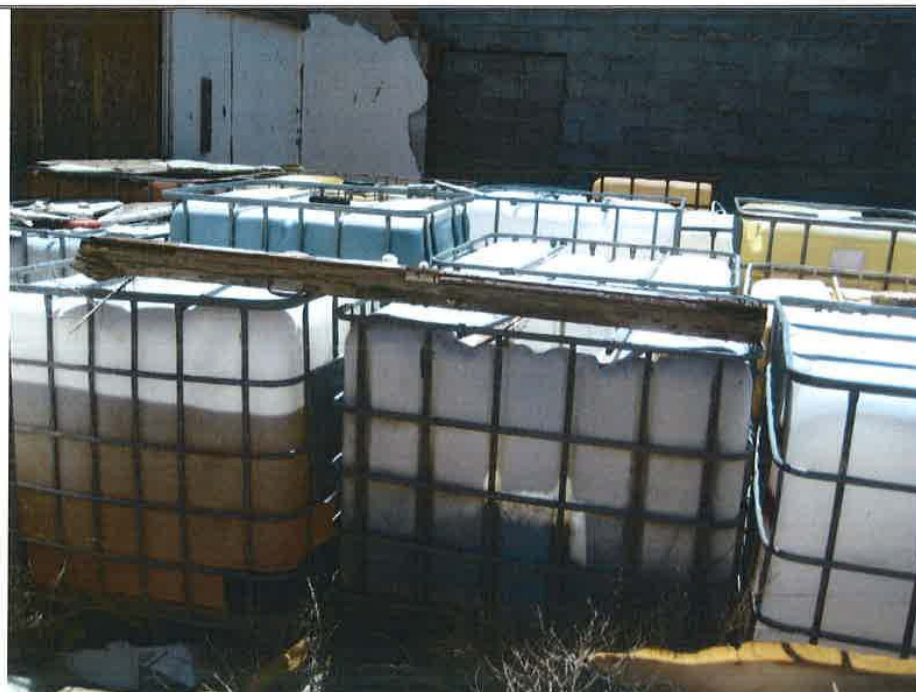
11) UNA Site

Looking south at the chemical totes that have unknown waste substances in some of them. No proper labeling of the contents of the containers was observed.

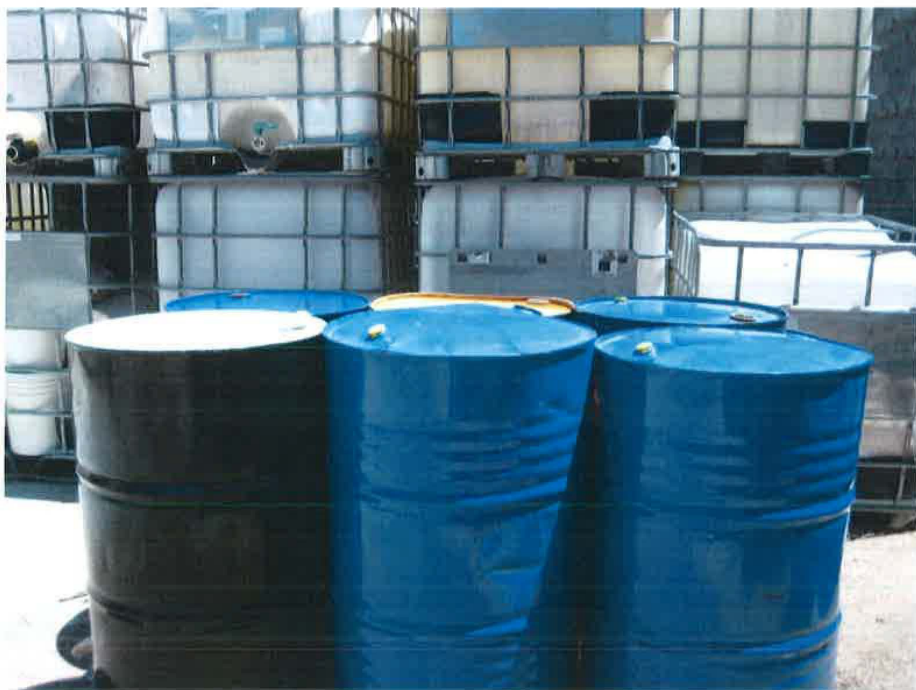
12) UNA Site

Looking east at six drums with no labeling in front of the chemical totes. Three of the drums are bulging on the top.

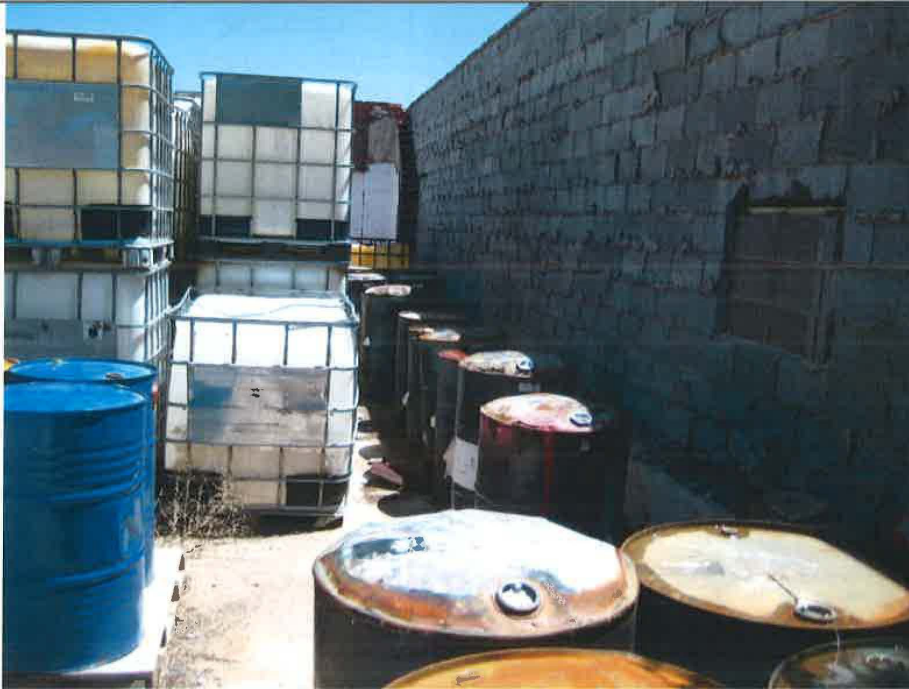
13) UNA Site

Looking east along the south side of the inside of the building. Multiple drums are stored that are bulging. Some are bulging on both ends of the drums. Unknown as to the waste contents. Many drums have dried paint on the tops and sides. No proper labeling was observed.

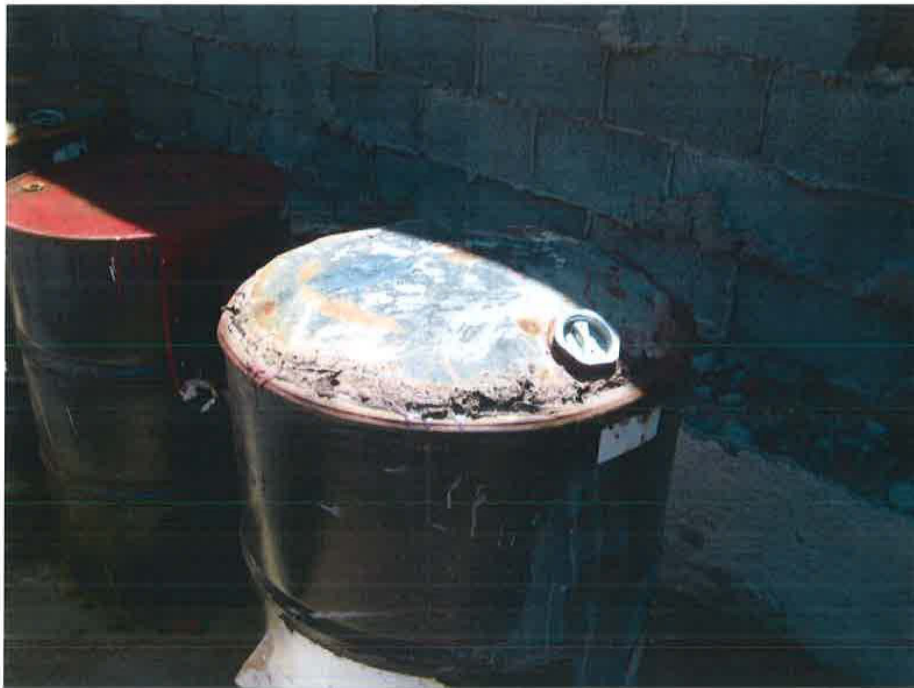
14) UNA Site

Close-up of one of the drums along the south wall. Drum is bulging. Dried paint was visible on the drum top and sides.

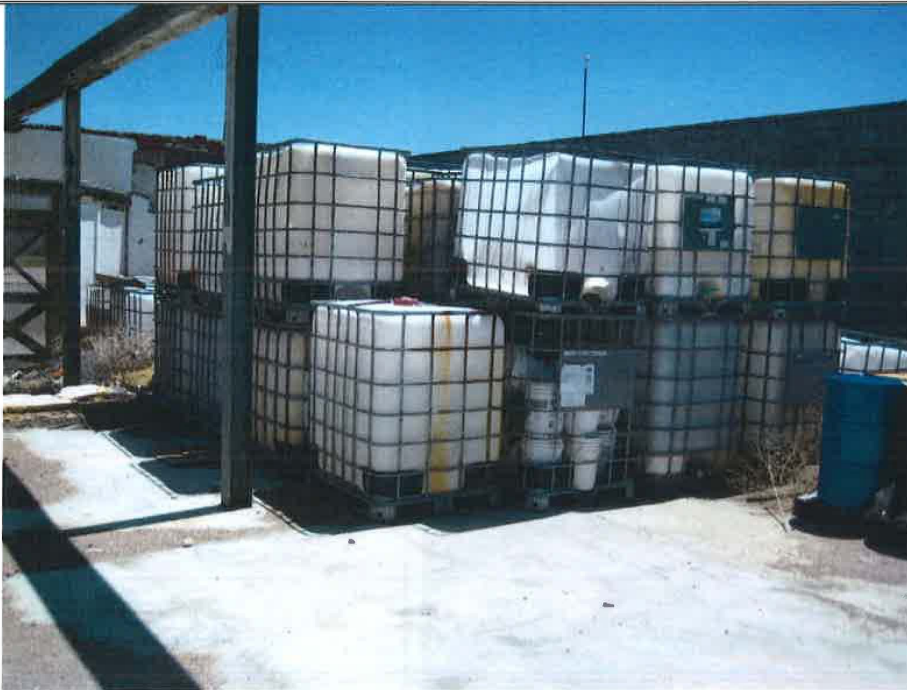
15) UNA Site

Looking southeast at the chemical totes in the southeast corner of the building.

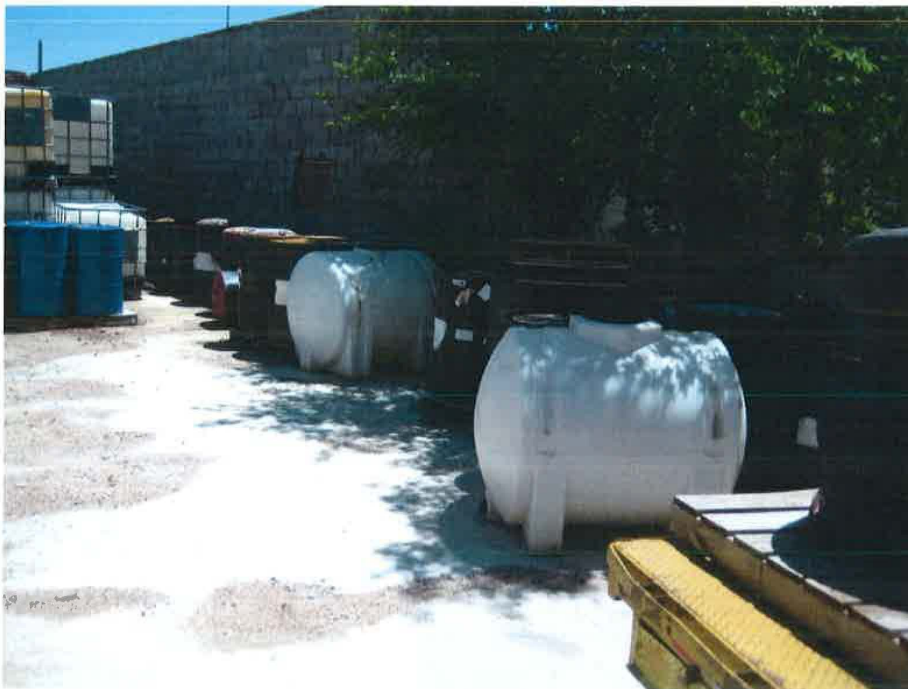
16) UNA Site

Multiple drums and poly tanks are stored in this area. Unknown as to their waste contents. No proper labeling was observed.

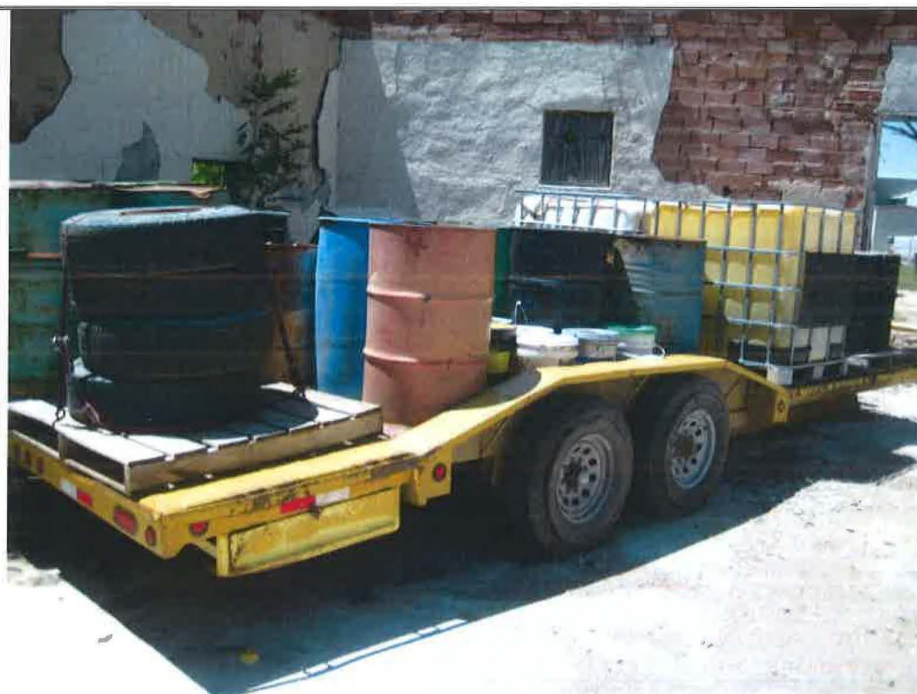
17) UNA Site

Looking west in the southwest corner of the building. Trailer has multiple unlabeled drums, 5 gallon buckets, overpack and chemical totes. Contents are unknown.

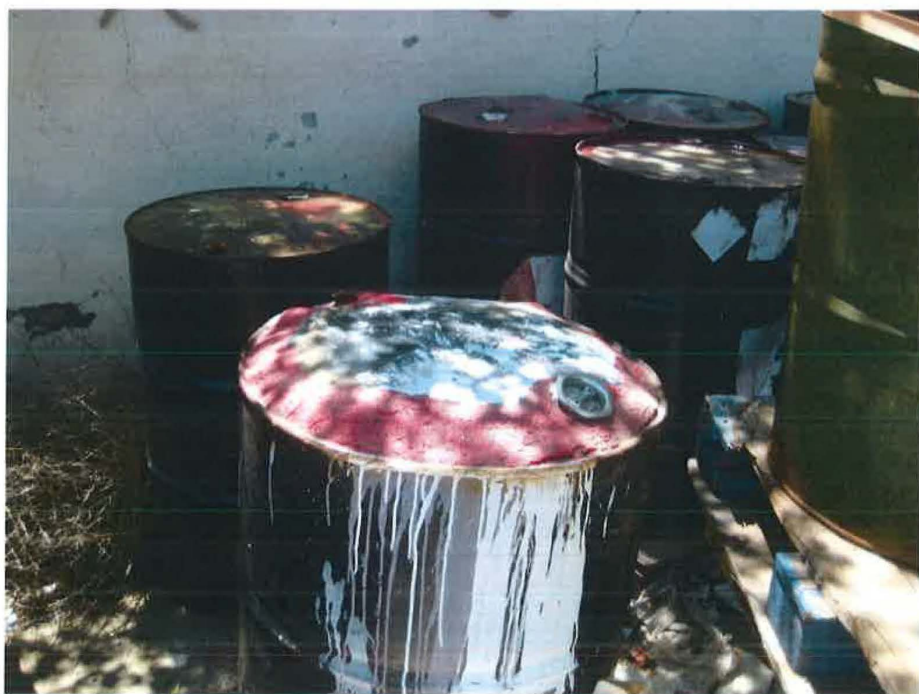
18) UNA Site

Multiple drums are stored in the southwest corner of the building behind the yellow trailer from photo #17. Drums are bulging with no proper labeling as to their current waste contents.

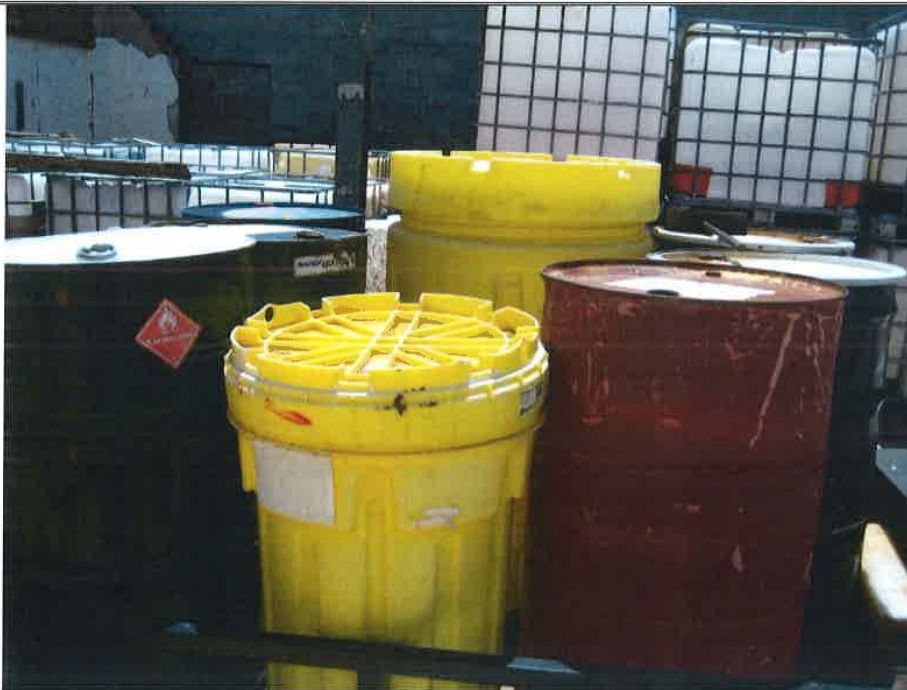
19) UNA Site

Looking at the small trailer in the northeast corner of the building. It is unknown if the overpacks contain any waste. Drums and overpacks were not labeled.

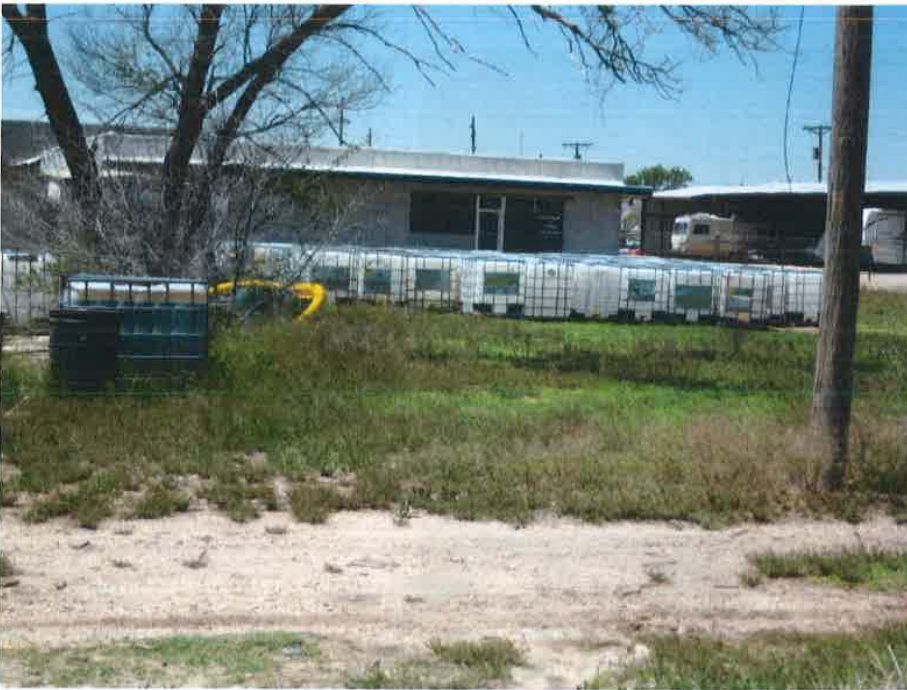
20) UNA Site

The area behind the building across the alley to the west is being used by the RE. There was a large concrete pad observed to have a release of some waste substance (see photos 20-31). It appeared at least one of the totes had been rinsed out on the pad and allowed to discharge onto the concrete pad and surrounding soil on the southwest and west side of the concrete pad in violation of 30 TAC §330.15(c) & §26.121(see photos 22-28). The discharge of waste onto the ground ran off the concrete pad along the south side of the two storage buildings and along the west side of the storage building doors. A very strong odor of acid and/or chemical was noted in this area. Absorbent was observed in this area scattered on the concrete pad and surrounding soil (see photos 22-27). A pile of absorbent with staining was also observed on the concrete pad (see photo 22). There are 8 chemical totes in the

Looking west from the backdoor of the building. Approximately 100 chemical totes were stored in this area. Majority of the totes were empty or only had residue. Multiple totes had unknown waste substances in them. Some of them were full.

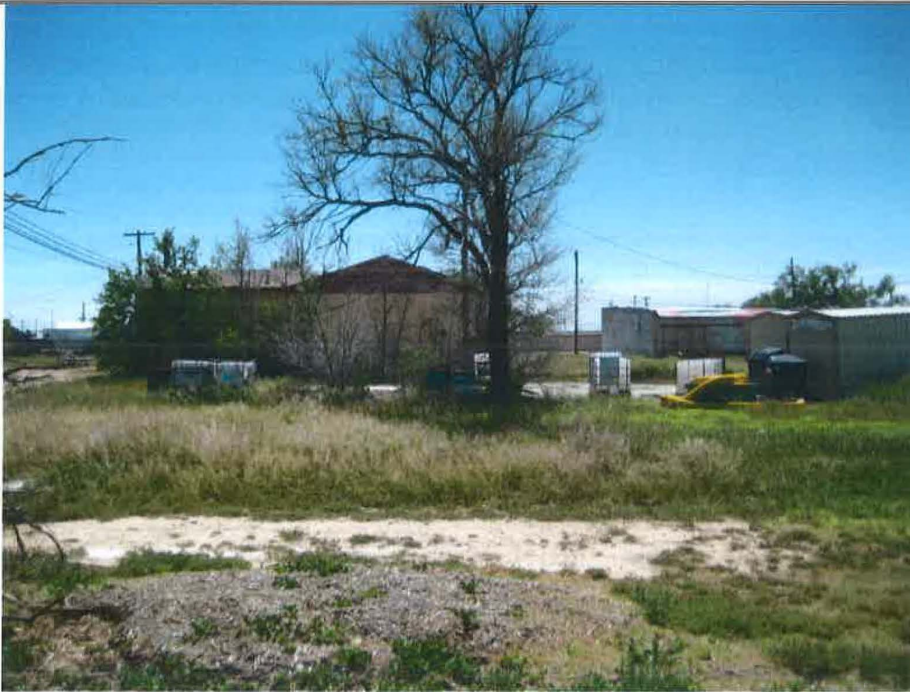
21) UNA Site

Looking south at the concrete pad area and two storage buildings.

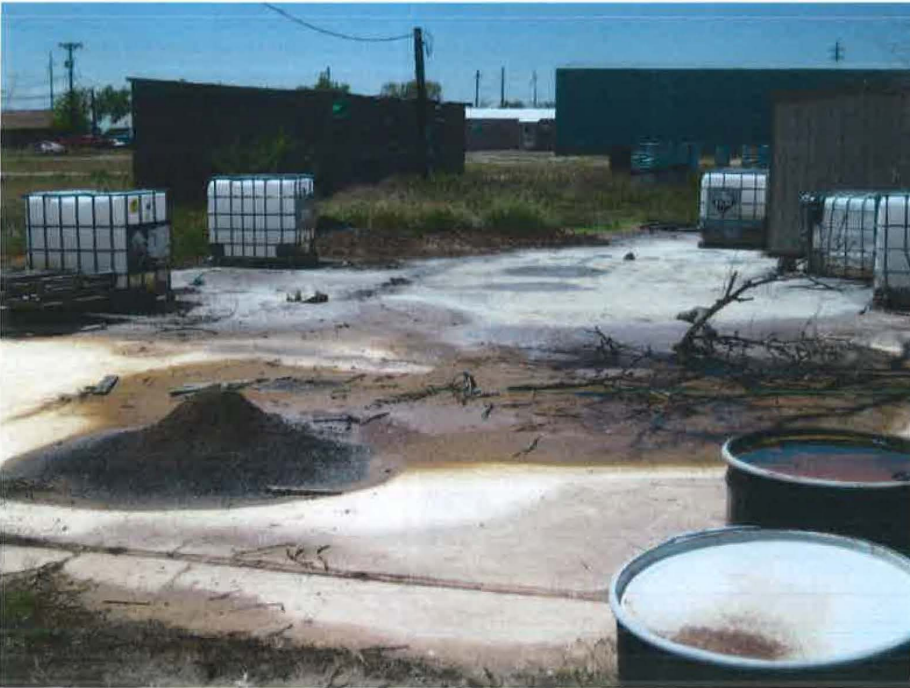
22) UNA Site

Failure to prevent the discharge of an unknown waste substance onto the ground. The soil was stained and vegetation damaged. There was a strong chemical/acid odor in the immediate areas of the discharge.

Looking west at concrete pad. It was observed that a release of an unknown waste substance occurred in this area. There is absorbent spread across the concrete pad and west in the soil on the south side of the storage buildings. It was noted that a strong chemical/acid smell permeated the air in this area.

Recommended Corrective Action: The RE must clean-up the discharged unknown waste substance from the concrete pad and surrounding soil areas. Documentation of corrective action must be submitted to the TCEQ.

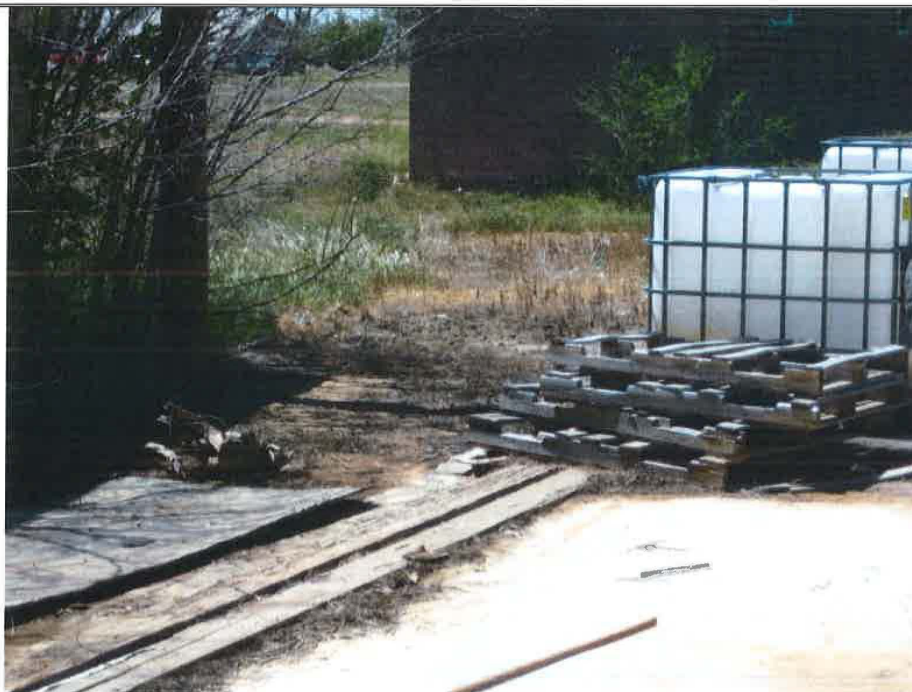
23) UNA Site

Looking southwest at concrete pad. It was observed that a release of an unknown waste substance occurred in this area. The release left the pad and ran along the south side of the pad in the soil. Vegetation was damaged in this area. It was noted that a strong chemical/acid smell permeated the air in this area.

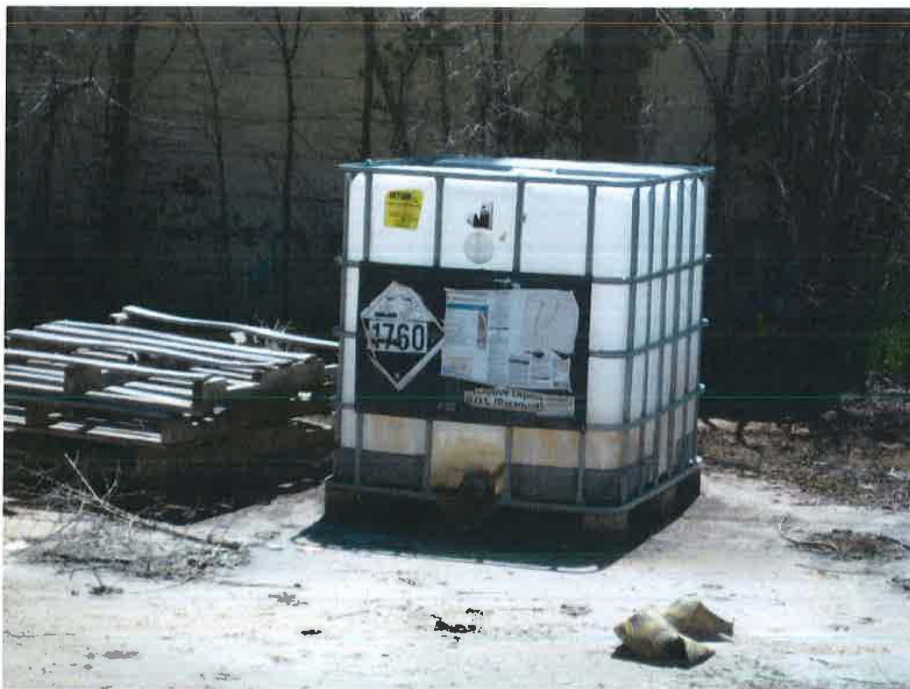
24) UNA Site

One of the totes stored on the concrete pad. The tote is labeled corrosive and 55% phosphoric acid.

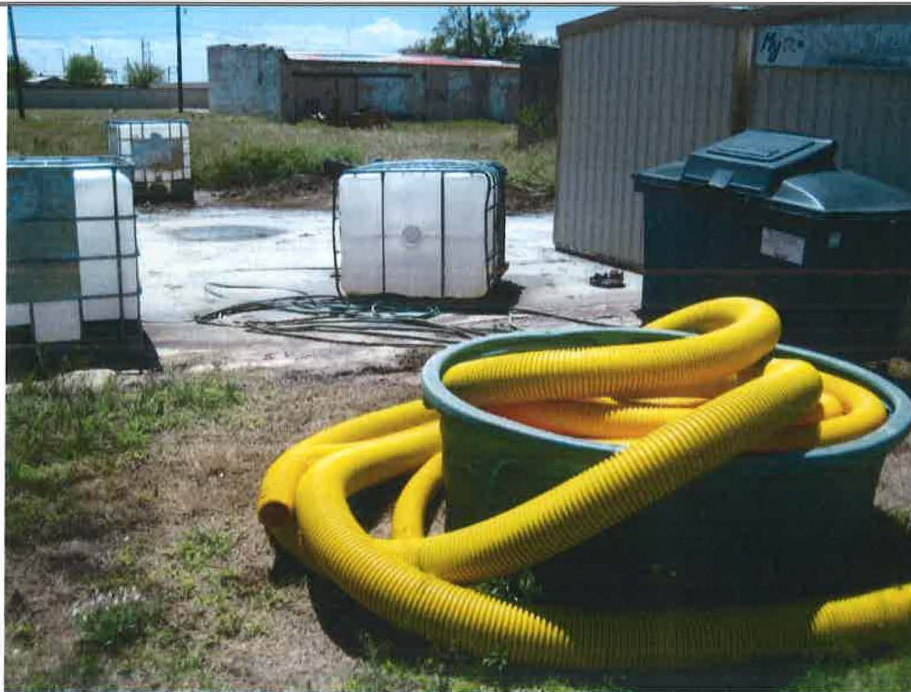
25) UNA Site

Looking west at concrete pad. It was observed that a release of an unknown substance occurred in this area. There is absorbent spread across the concrete pad and west in the soil on the south side of the storage buildings. It was noted that a strong chemical/acid smell permeated the air in this area. Water hoses are corroded.

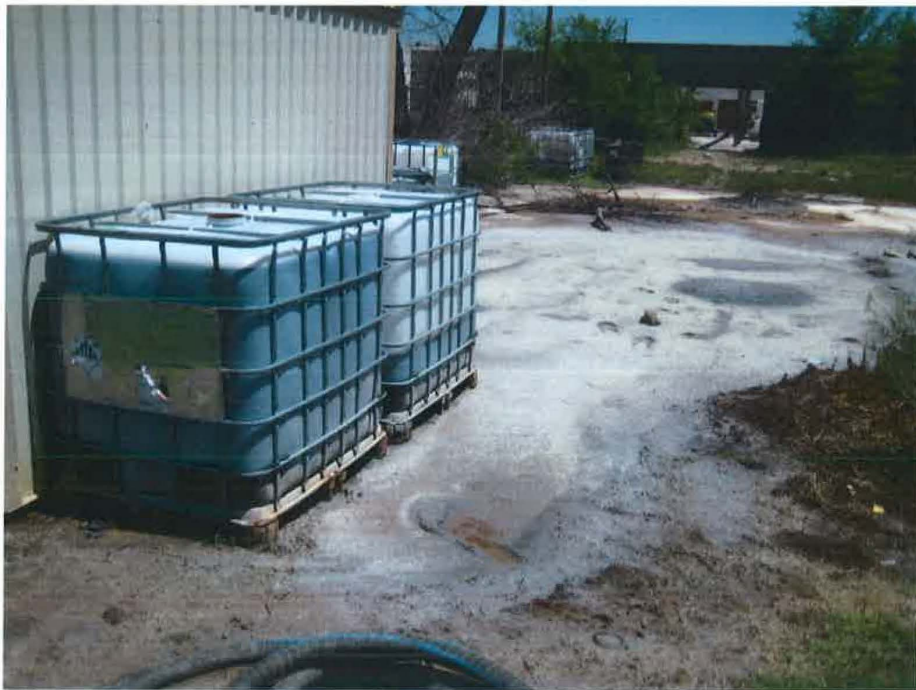
26) UNA Site

Looking east at concrete pad and south side of the storage buildings. It was observed that a release of an unknown substance occurred in this area. There is absorbent spread across the concrete pad and west in the soil on the south side of the storage buildings. It was noted that a strong chemical/acid smell permeated the air in this area. Chemical totes have unknown waste substance in them. Neither tote was closed or labeled as to their contents.

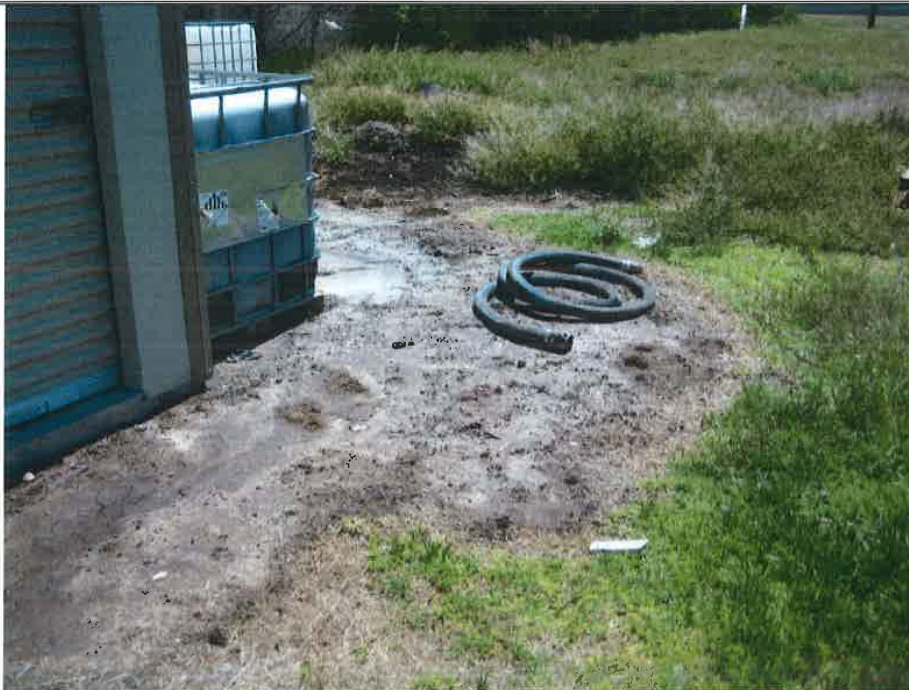
27) UNA Site

Looking southeast at soil surrounding storage buildings. It was observed that a release of an unknown substance occurred in this area. There is absorbent spread across the soil on the south and west sides of the storage buildings. It was noted that a strong chemical/acid smell permeated the air in this area.

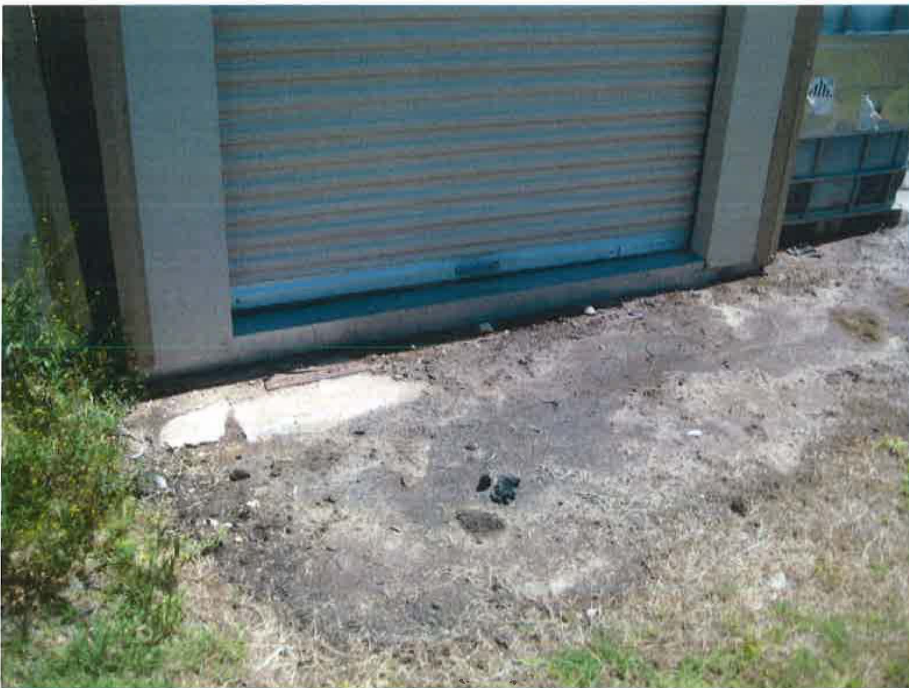
28) UNA Site

Looking east at soil in front of the south storage building. It was observed that a release of an unknown substance occurred in this area. There is absorbent spread across the soil on the south and west sides of the storage buildings. It was noted that a strong chemical/acid smell permeated the air in this area.

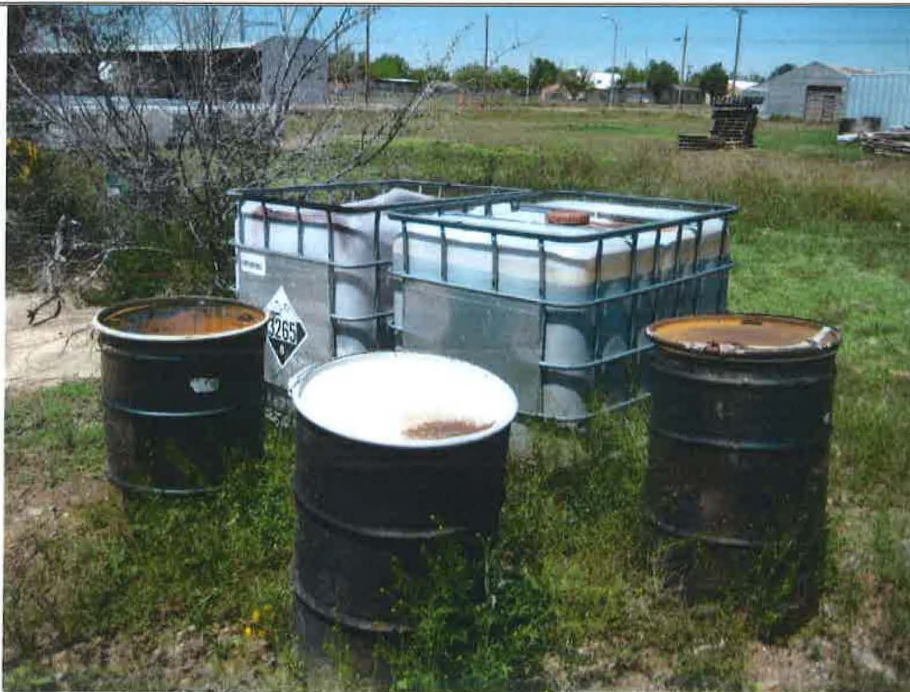
29) UNA Site

Looking northwest at three drums and two chemical totes north of the concrete pad as noted in photos 21-25. Unknown as to the contents of the drums and totes. The west tote has an open top and full of a dark substance with a corrosive label on the side. The east tote is full with an unknown waste substance.

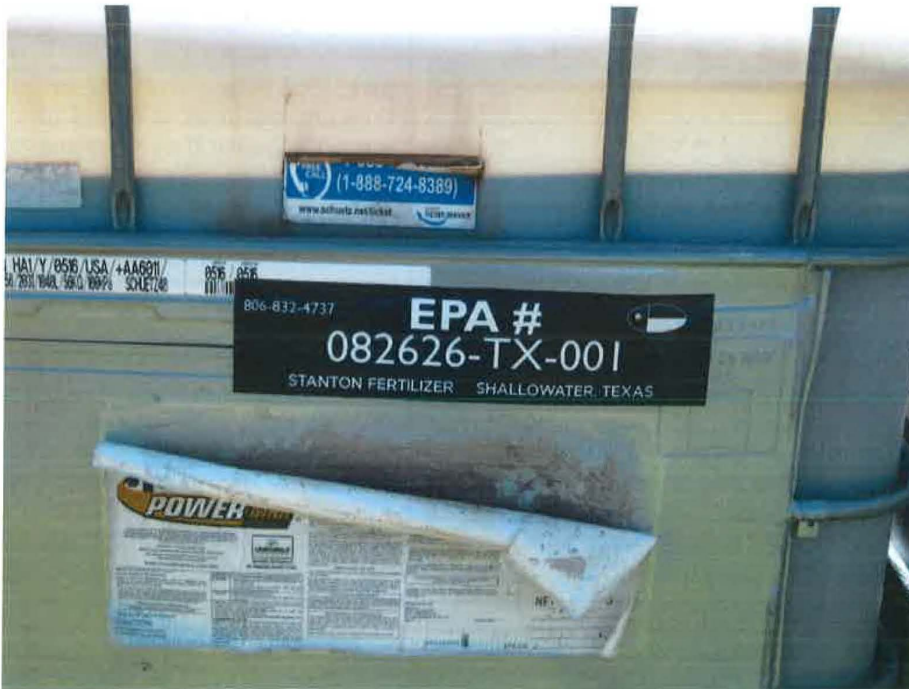
30) UNA Site

area either on the concrete pad or to the edge on the soil. Four of these totes contain some type of waste material which appears to be used oil in violation of 30 TAC §324.4.

East chemical tote as noted in photo #29. Tote is full. Unknown if the waste substance in the tote is what is depicted on the label. The substance appears to be used oil.

Recommended Corrective Action: The RE must obtain a used oil transporter and storage registration prior to conducting such activities. All unauthorized storage of used oil must be disposed of or recycled at an authorized disposal/recycling facility. Documentation of corrective action must be submitted to the TCEQ.

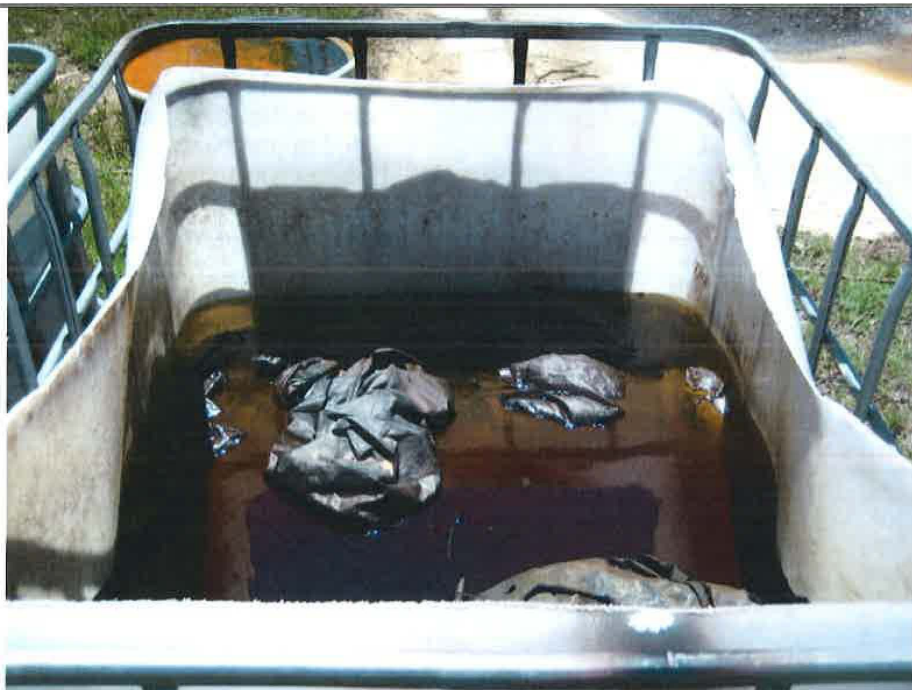
31) UNA Site

West chemical tote as noted in photo #29. Tote is half full. Unknown if the waste substance in tote is what is depicted on the label showing corrosive. The substance appears to be used oil and water.

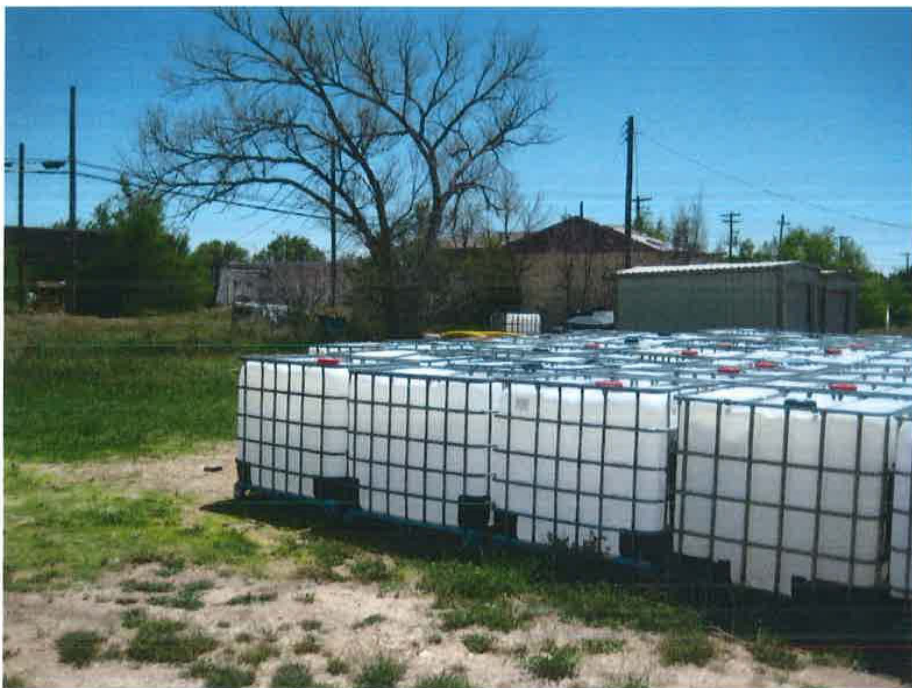
32) UNA Site

The investigators observed approximately 100 chemical totes were being stored northwest of the concrete pad (see photos 32 & 33). It is unknown if all of these totes are empty by definition. On the south end of the totes was one tote that was approximately $\frac{3}{4}$ full of an unknown waste (see photo 34). There are 4 galvanized tubs that contained water and some sort of algae growth (see photo 34 -37). It is unknown if these containers have a sealed bottom or if there is bare ground on the bottom of the tubs. There is one black plastic container that has an oily sheen on the top of the waste fluid (see photo 38). There were no lids present on the four tubs or black container. These are open to the elements and rainfall could cause the containers to overflow onto the ground. The investigators observed numerous 55-gallon drums being stored unsecured in the elements between the two storage buildings and the totes. It appeared that the drums had the lids secured except for one drum with no lid. This drum appeared to have some type of waste oil in it. None of the drums were labeled as to their contents. One overpack was observed in this area and appeared to contain some type of waste. No sampling was conducted due to safety concerns of what unknown waste was discharged on the ground with such a strong chemical/acid odor.

Looking southeast at chemical totes. Unknown if all totes are empty in this area.
